SPRING 2001

# Flight Comment

### Directorate of Flight Safety

### The Canadian Forces Flight Safety Magazine

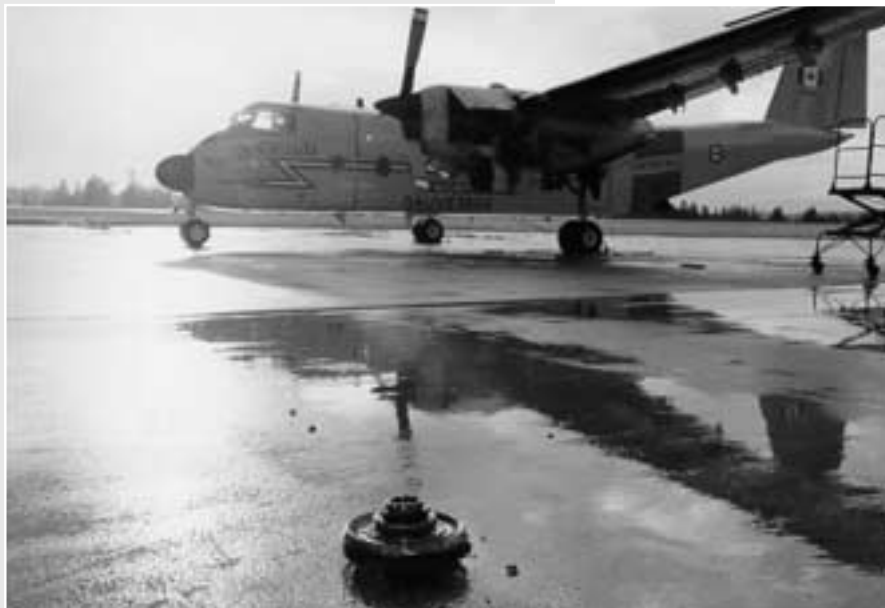
**TYPE:** CC115465  
**LOCATION:** Comox, BC  
**DATE:** 07 Feb 1998

Three technicians were conducting a maintenance ground run on Buffalo 115465 following engine maintenance. The run-up was conducted in accordance with the checklist and included the Power Lever Burst (PLB) procedure, which directed that the power lever be moved from the maximum forward thrust position to the maximum reverse thrust position within one second. During this procedure an unfamiliar engine sound was heard, followed immediately by a loud explosion and fire. The LH power lever was moved to idle and fire emergency procedures were carried out. Pulling the LH FIRE PULL T-Bar handle failed to activate the fire extinguisher and attempts to activate the second fire bottle failed. The RH engine was shut down and the aircraft evacuated. Three fire trucks arrived approximately 2.5 minutes later and extinguished the fire in approximately 3 minutes. There were no injuries in the accident, however, the aircraft sustained Category 'C' damage.

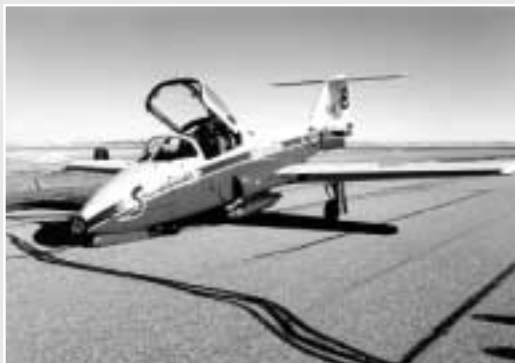
**TYPE:** CT114019  
**DATE:** 27 Feb 1999  
**LOCATION:** 15 Wing Moose Jaw,  
Runway 29R

The aircraft was number six of a 7-plane formation landing after an on-field air show practice at 15 Wing Moose Jaw on 27 February 1999. During touchdown on runway 29R, the aircraft experienced a firm landing. The aircraft then bounced and became airborne again. The nose of the aircraft then rotated quickly towards the ground and the nose landing gear contacted the runway surface heavily. The aircraft veered to the right, the nose landing gear collapsed and the pilot maintained directional control using differential braking. The aircraft then skidded to a stop. There was no interference with the rest of the formation. The pilot shut down the engine, turned off electrical equipment and egressed from the aircraft. Fire fighting vehicles and an ambulance arrived on scene within minutes, but were not utilised. There were no injuries.

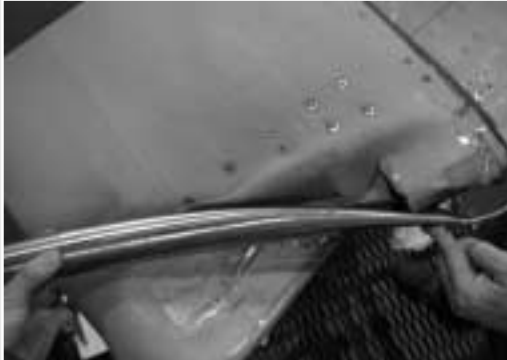
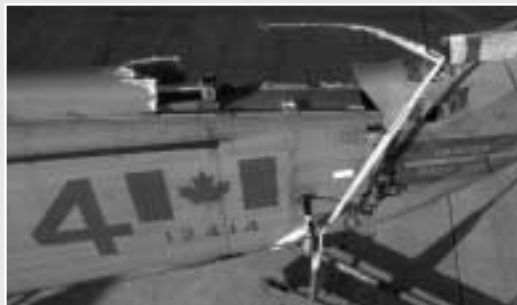
**TYPE:** CH-124A414 Sea King  
**DATE:** 16 June 1999  
**LOCATION:** Shearwater, NS

At 1420 Z 16 June 1999, a crew from 406 (HT) Squadron, consisting of one Waterbird Instructor Pilot and one Airborne Electronic Sensor Operator (AESOP), had just completed a crew change of the right seat student pilot on the ramp at Shearwater.

The investigation concluded that a departure from the expected chain of events distracted the crew at a critical time, resulting in C Category damage to the aircraft.

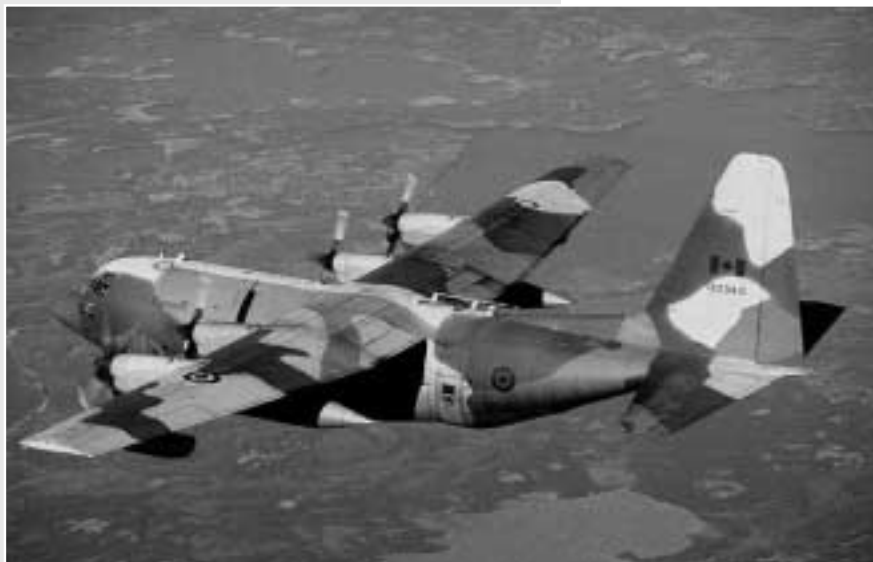
**TYPE:** CC130325  
**LOCATION:** 90 NM North West of Thule Air Base, Greenland  
**DATE:** 27 Aug 1998

During Operation BOXTOP a crew was on a daylight flight from Thule, Greenland to Eureka, NWT, to position two non-flying CC 130 crews to recover two diverted aircraft. A malfunctioning cargo compartment pressurization system led to a gradual increase in the cabin altitude such that at FL180 the cabin altitude was 10,000 feet. While attempting to rectify the pressurisation problem the cabin altitude reached 14–15,000 feet. At that point a non-flying aircraft commander (AC) proceeded to the cockpit to inform the crew that he and others were experiencing symptoms of hypoxia. He recommended, to the flying AC, a descent to 10,000 feet and the use of oxygen for the flying crew. The emergency checklist was actioned and due to calculated Minimum Obstruction Clearance Altitude (MOCA) the aircraft was descended to 13,000 feet (11,000 — cabin altitude), followed, 15 minutes later, by a descent to 10,000 feet. With below limits weather at Eureka, the aircraft returned to Thule at 10,000 feet without further

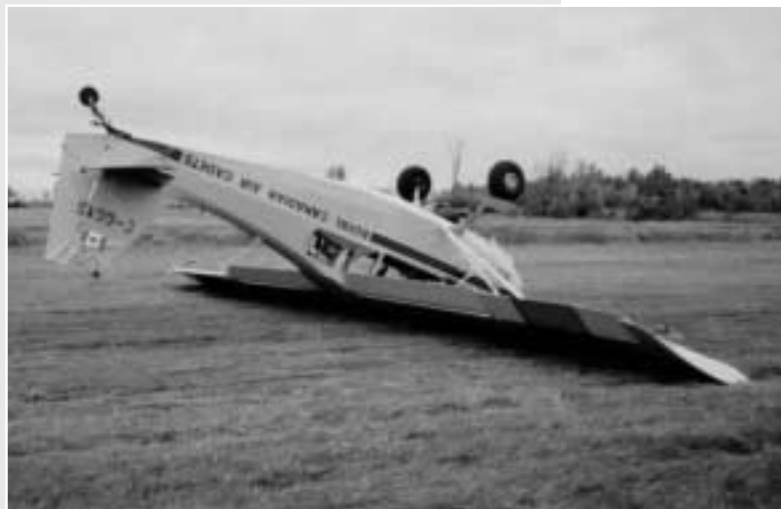
**TYPE:** Bellanca Scout C-GGYS  
**DATE:** 8 October 2000  
**LOCATION:** Alexandria, Ontario

One tow aircraft and two gliders from the Quinte Gliding Centre (Mountainview) were deployed to the Alexandria municipal airport to provide local Air Cadet squadrons glider familiarisation flights as mandated in the Air Cadet Gliding Program. The experienced pilot of the accident aircraft took off at approximately 0815 on the Sunday morning and carried out nine successful glider tows. On landing from his ninth tow, the pilot was observed to be slightly “longer” than previously. The aircraft landed slightly farther than normal and heavier braking was used in order to stop at the launch point.

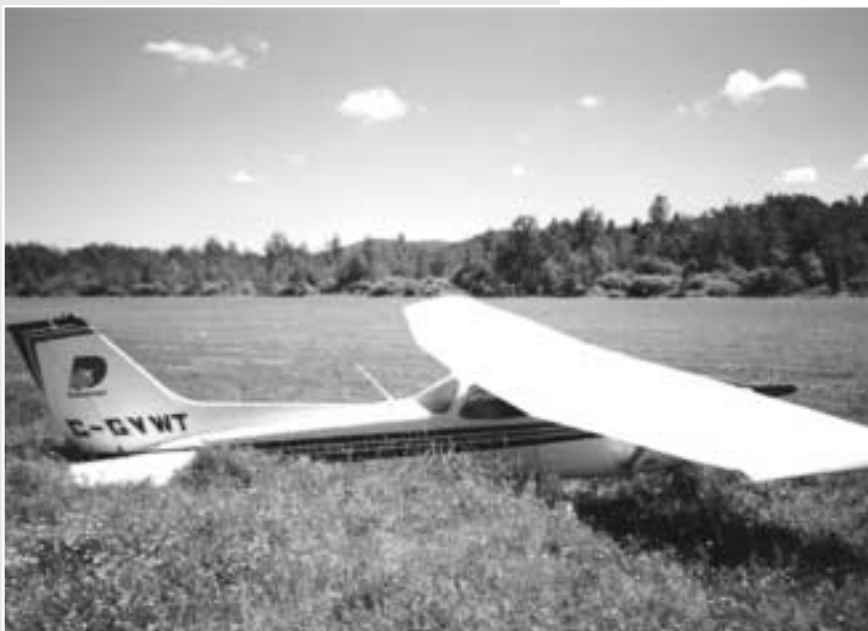
**TYPE:** Cessna 172 C-GVWT  
**DATE:** 26 July 2000  
**LOCATION:** Bromont, Québec

On the morning of 26 July 2000, a solo Air Cadet undergoing private pilot training under the Air Cadet flying scholarship program, departed St-Jean PQ for Bromont PQ in a Cessna 172M. The purposes of the flight were to acquire more solo cross country time in order to meet the 5 hours requirement for the private pilot licence and to practise touch and go landings away from the student's base at St-Jean as that airport was also host to the Air Cadet League's regional glider school and the circuit was very busy.

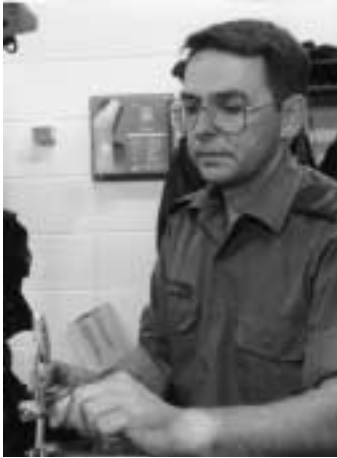
### CORPORAL CHRIS GRAHAM

On 8 May 2000, Corporal Graham was carrying out maintenance on the fire protective system inside the APU bay of Challenger aircraft CC144606. He noticed two red plastic caps on the lower left side of the airframe. Further inspection revealed that the oxygen fill port and quantity gauge

The consequences of this improperly installed oxygen filler assembly being utilized could have been a serious aircraft emergency. Corporal Graham should be commended for his exceptional attention and professional attitude, which resulted in the identification and removal of a potentially lethal hazard. ♦
